***2017 ASPECT Preliminary Report
Arkema Plant Response
Crosby, TX***

***August 31, 2017
0600 hrs to 1900 hrs***

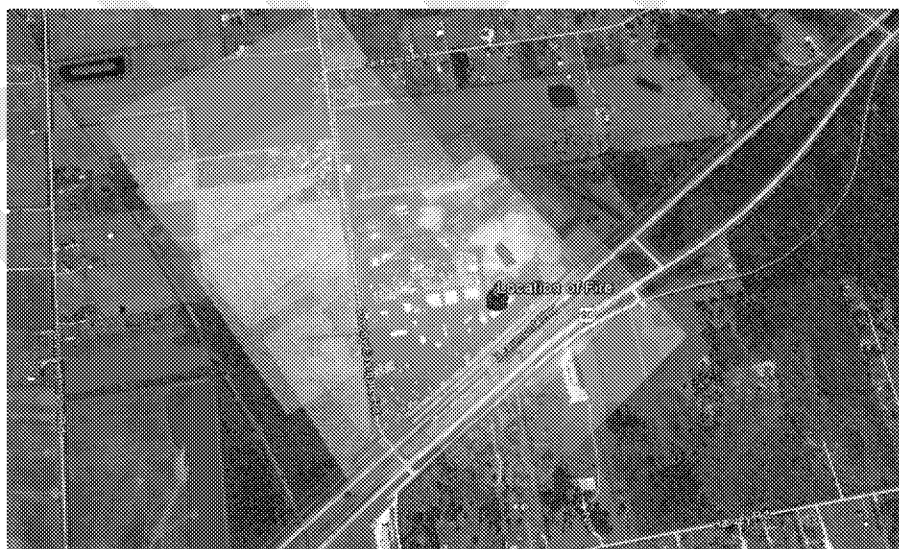
Figures 2 & 3 show a visible image of the facility with no observed plume and the flight path highlighted when IR sensors were active.

Figure 2: Low resolution aerial images pulled from the aircraft while in flight over the facility, 30 August 2017 at about 0730 hrs CST.

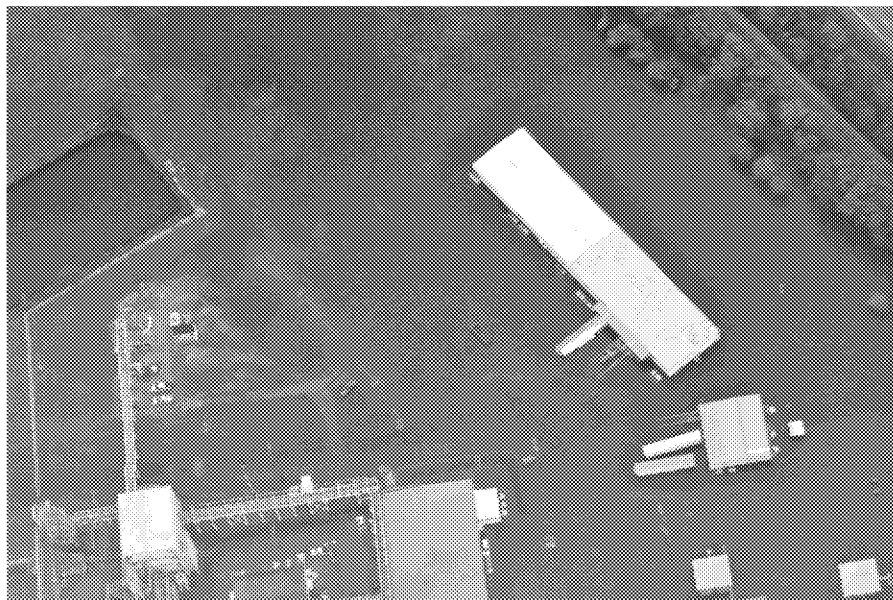
Figure 3: Oblique photo prior to explosion/fire on 30 August 2017.

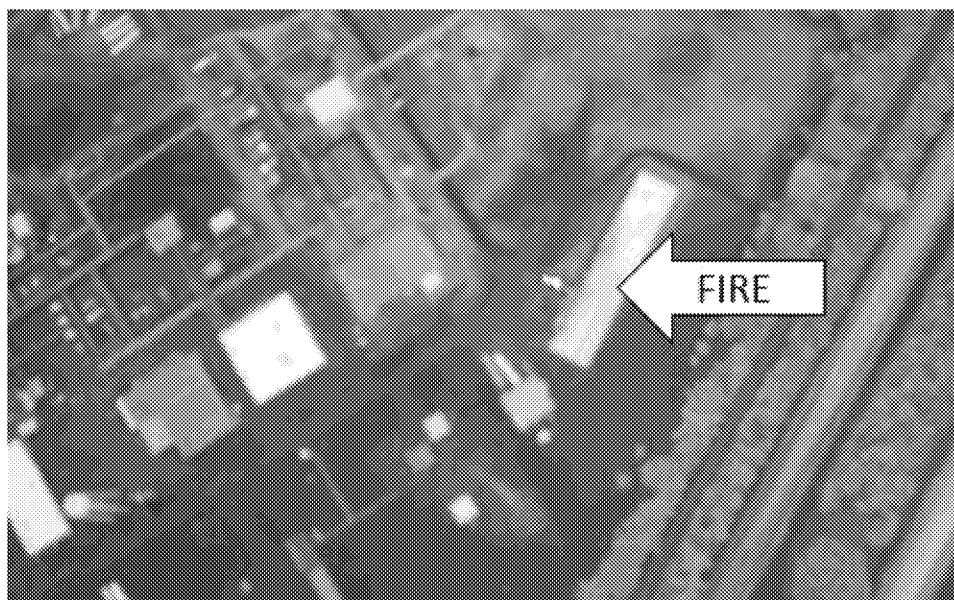
High-resolution aerial photos provide downward view of the area. Figure 5 has been enhanced due to poor visual conditions when the aircraft arrived on site. Foggy weather combined with low light conditions is reflected in this image.

Figure 5: Aerial photo over the site captured during the morning flight on 31 August 2017.

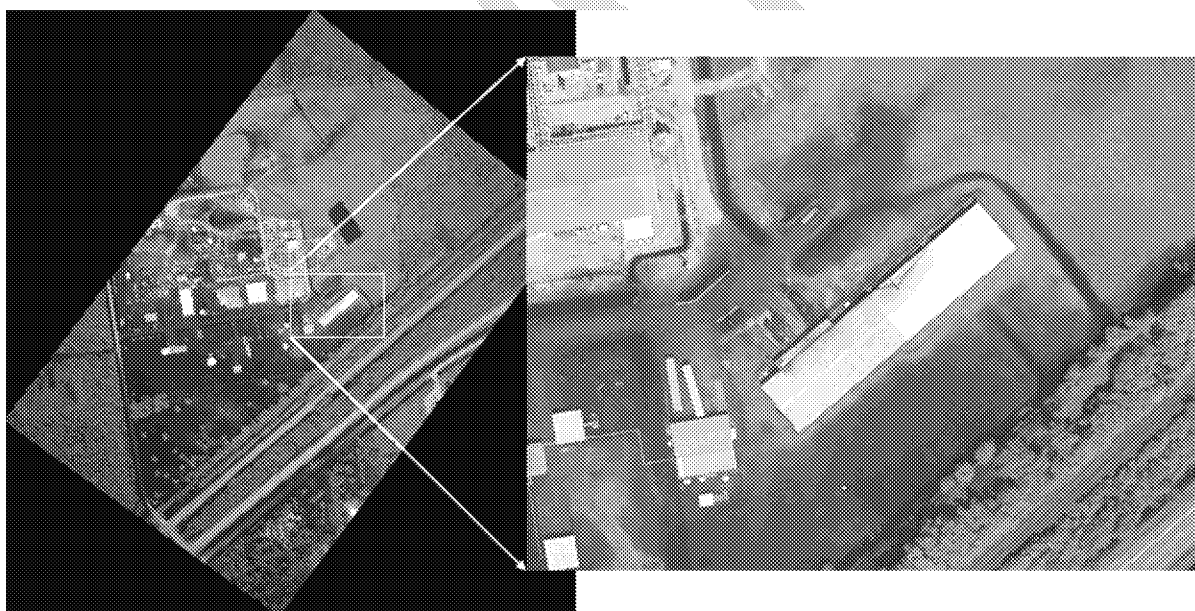
Figure 6: Low resolution aerial image retrieved from the aircraft during the afternoon sortie, approximately 1335 hrs. A copy of the entire image will be provided in an email. A portion of the photo was enlarged to show the affected building.

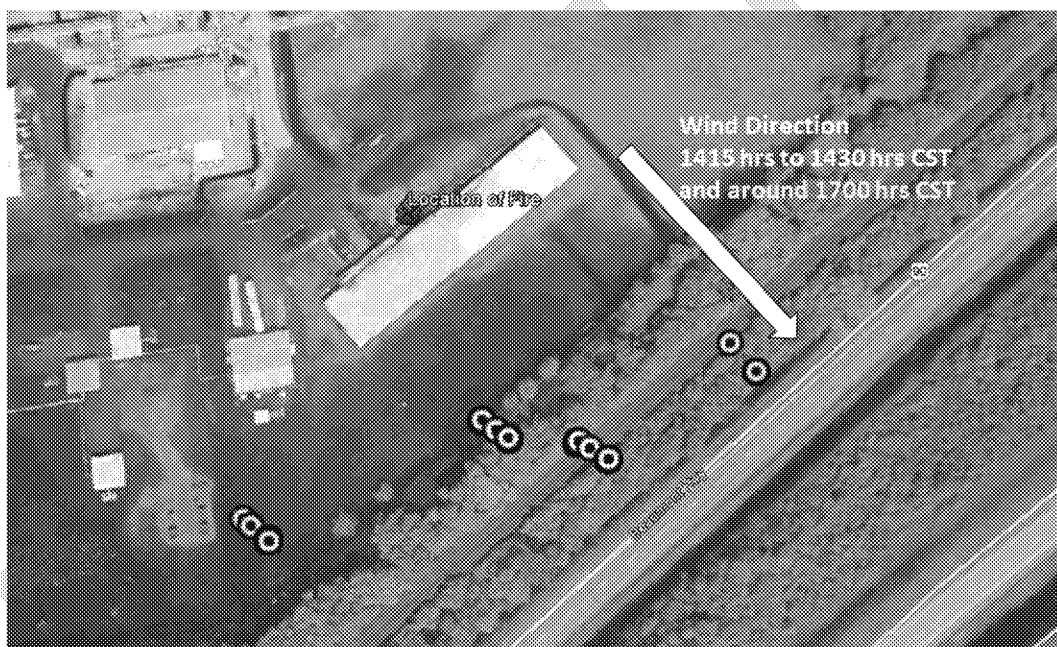
Figure 10: Location of “weak” peroxide detections during ASPECT passes conducted between 1415 hrs and 1700 hrs. All detections are within the symbols shown in the image. Our collection frequency (70 measurements per second) caused many of the symbols to overlap. White dots collected during Flight 4. Yellow dots collected during Flight 5.

1710 hrs and 1730 hrs ASPECT reported detections consistent with benzoyl peroxide over the site at approximately the same location shown in Figure 10.

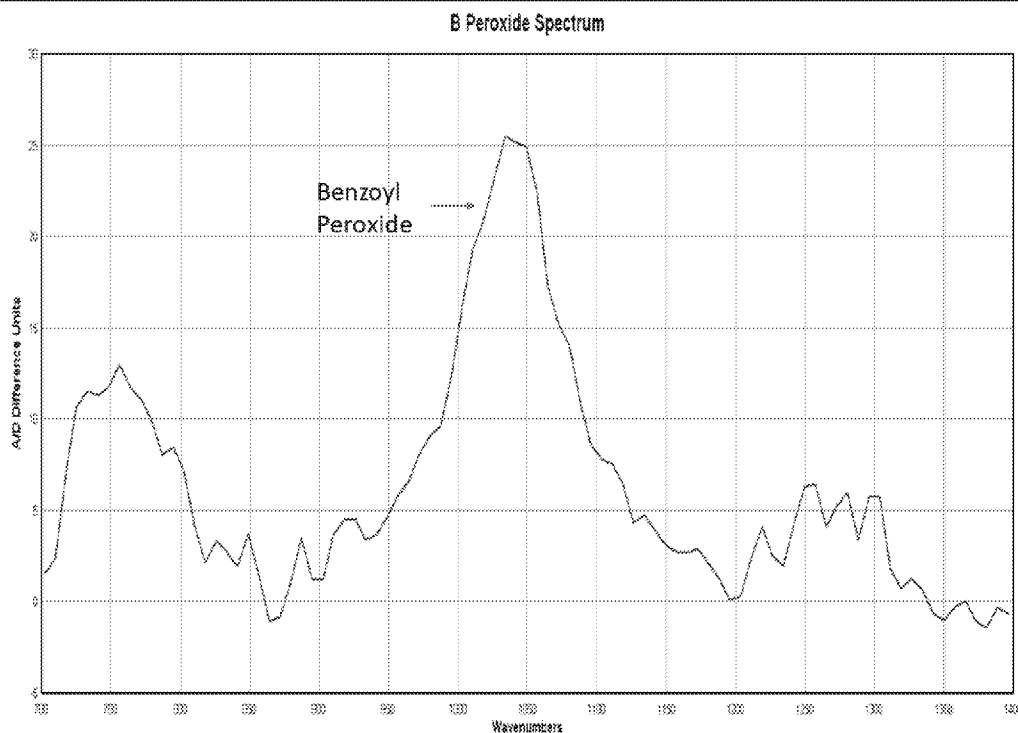
Figure 11: FTIR spectra showing signature consistent with benzoyl peroxide vapors. The signature represents a typical spectra that exceeded our detection limit of about 5 ppm.

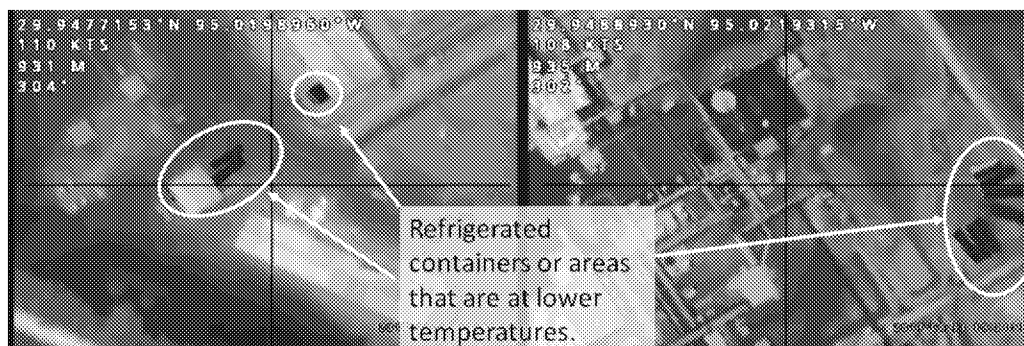
Figure 12 provides snap shots taken from an infrared video collected during the afternoon flight. Dark areas indicate lower temperatures. Eight tanks are identified in these images.

Figure 12: Infrared images obtained from an infrared video (1320 hrs CST) clearly showing heat signatures which identifies which containers are cooled (black colors) at the Arkema facility. Note the northernmost tank in the image to the right. It is painted blue which may affect its heat signature. These photos show eight tanks that are being refrigerated.
